# Manhole Inspection Summary

Manhole # S35KK1019MH

Insp Date: **3/12/07 3:31 PM**

**Location** Address: **4310 UNDERWOOD RD**

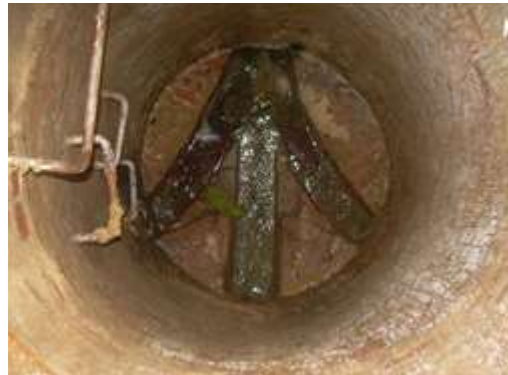
Top View

Bench debris.

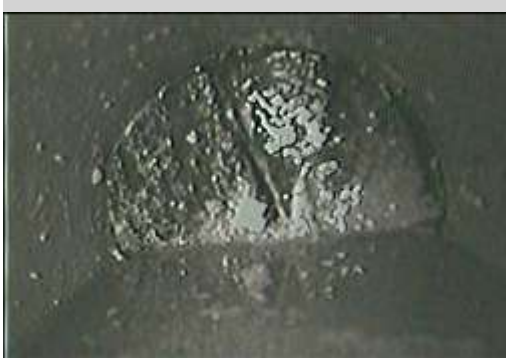
Inside the I5

Capped.

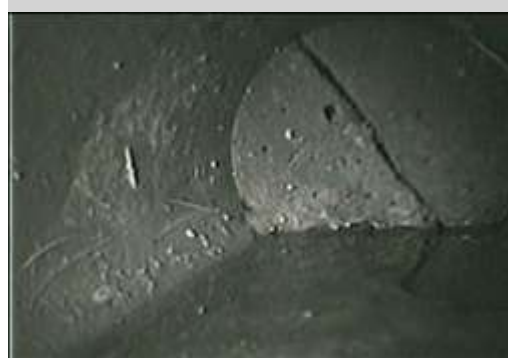
Inside the I7

Capped.

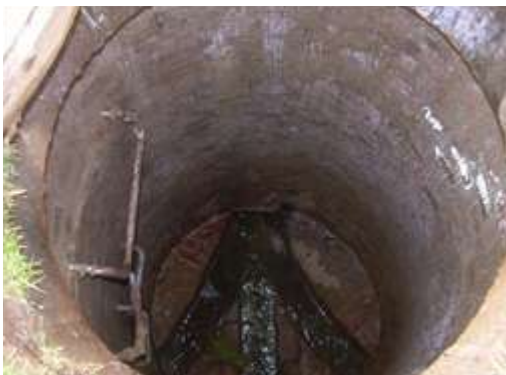
Defect

☒ **Leaks**

Infiltration: ☐ None ☒ **Joint** ☐ Cracks ☐ Mortar ☐ Roots ☒ **Wall**

Condition: ☐ Sound ☐ Cracked ☐ Root Intrusion ☐ Loose Brick ☒ **Deteriorated**

Infiltration: ☐ None ☐ Joint ☐ Cracks ☒ **Mortar** ☐ Roots ☒ **Wall**

Frame leaks. Corbel and Barrel infiltration.

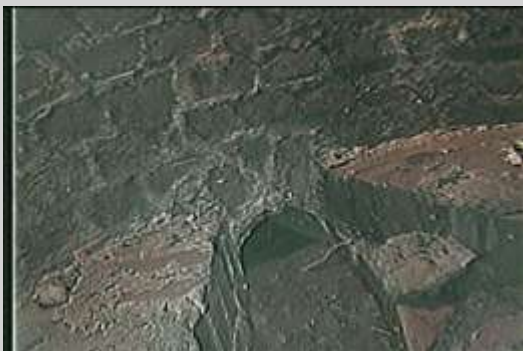
### 8 in. Circular Gravity Sewer Pipe In @ 5 O'Clock

Deposits: ☐ None ☒ **Mud** ☐ Sludge ☒ **Debris** ☐ Grease

Silt Depth: **3** (in.) Deposits Extent: **Medium**

Infiltration: **Evidence** Pipe Seal Cond: **Unknown**

Connects To: **Stub connection / abandoned**

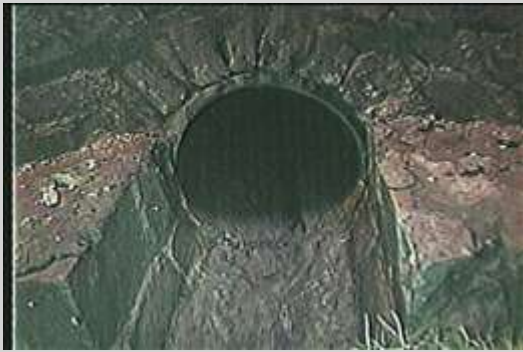
Pipe In @ 6 O'Clock

Barrel deterioration and infiltration. Channel deterioration.

Infiltration: **Evidence** Pipe Seal Cond: **Cracked**

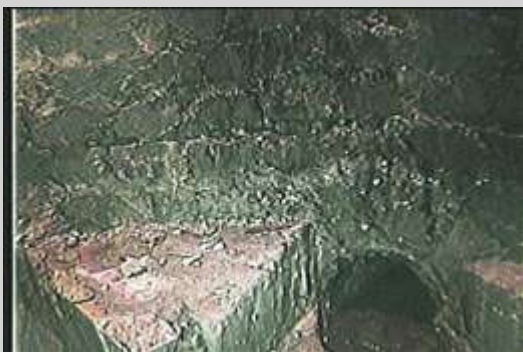
### Pipe In @ 7 O'Clock

Barrel deterioration and infiltration.

Deposits: ☐ None ☒ **Mud** ☐ Sludge ☒ **Debris** ☐ Grease

Silt Depth: **3** (in.) Deposits Extent: **Medium**
